# NOORVIK MATERIALS INVESTIGATION

Existing Alignment, Proposed Alignment and Material Sites

July 22 - 23, 1973

STATE OF ALASKA
DIVISION OF AVIATION
DESIGN SECTION

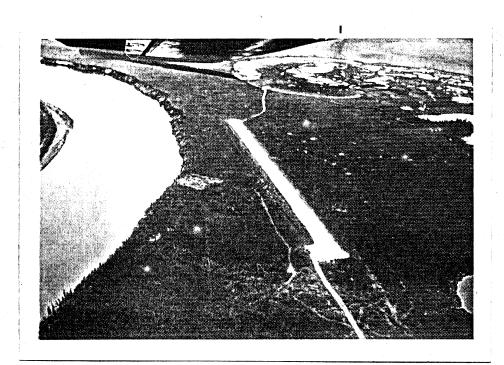
Noorvik airfield. Embankment material for construction of the cross-wind alignment can be obtained from the semidrained lakebed in the background.

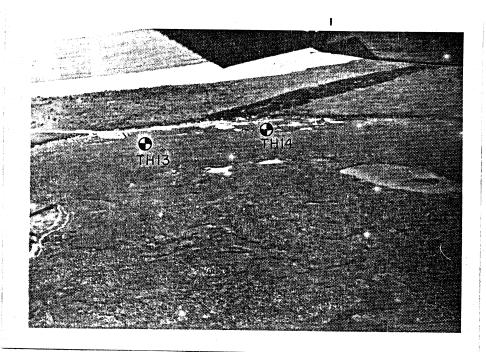
Semi-drained lakebed south of the airfield

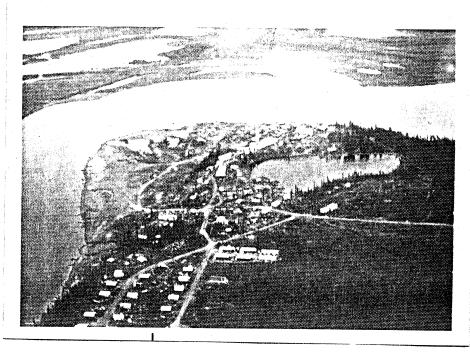
Embankment material for construction of the original runway came from the bar left of the village

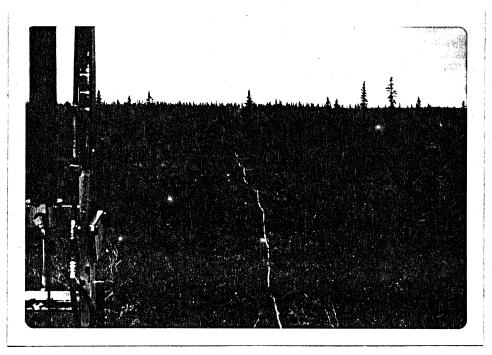
Drilling test hole 19 - view looking norTheasT along proposed alignment 7/23/73 D.P.

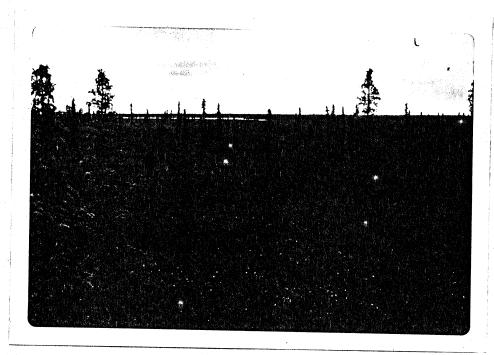
View looking southwest along proposed alignment from test hole 19. 7/23/73 D.P.

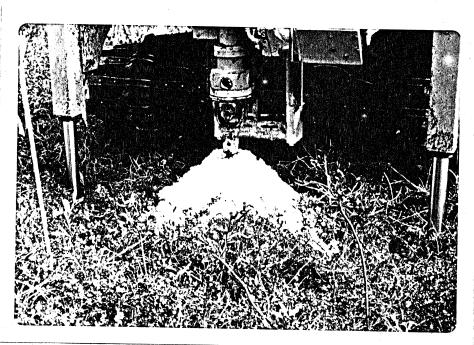
Test hole 1 - Ice below 4.5' 7/22/73 D.P.

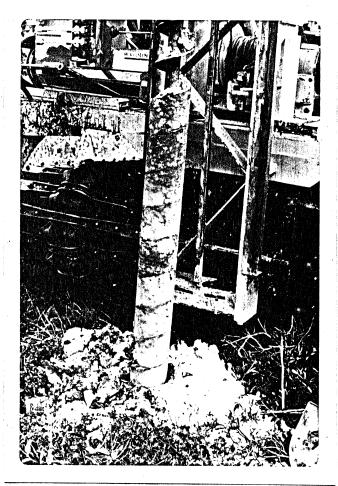
Test hole 5 - Ice below 4.5' 7/22/73 D.P.

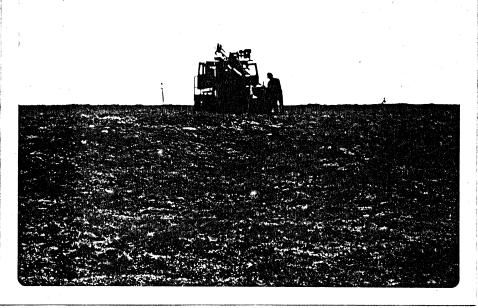
Noorvik Borrow Exploration - Drilling test hole 2. Borrow material consists of gravelly silty sand grading to gravelly sand in depth. Frost is present below 4.0. The material is an ancient beach deposit. 7/22/73 DP

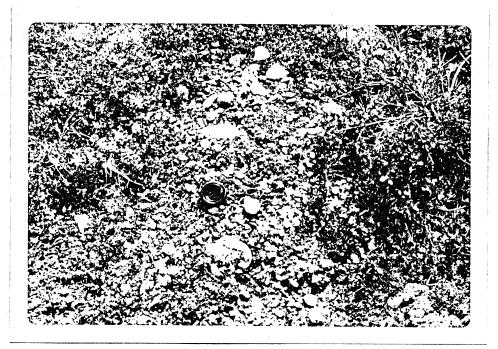
Noorvik Borrow Exploration - Surface material as found in the vicinity of test hole #2.7/22/73 D.P.
