GEOTECHNICAL REPORT

KIANA AIRPORT IMPROVEMENTS PROJECT

AKSAS 63179

APRIL 2013

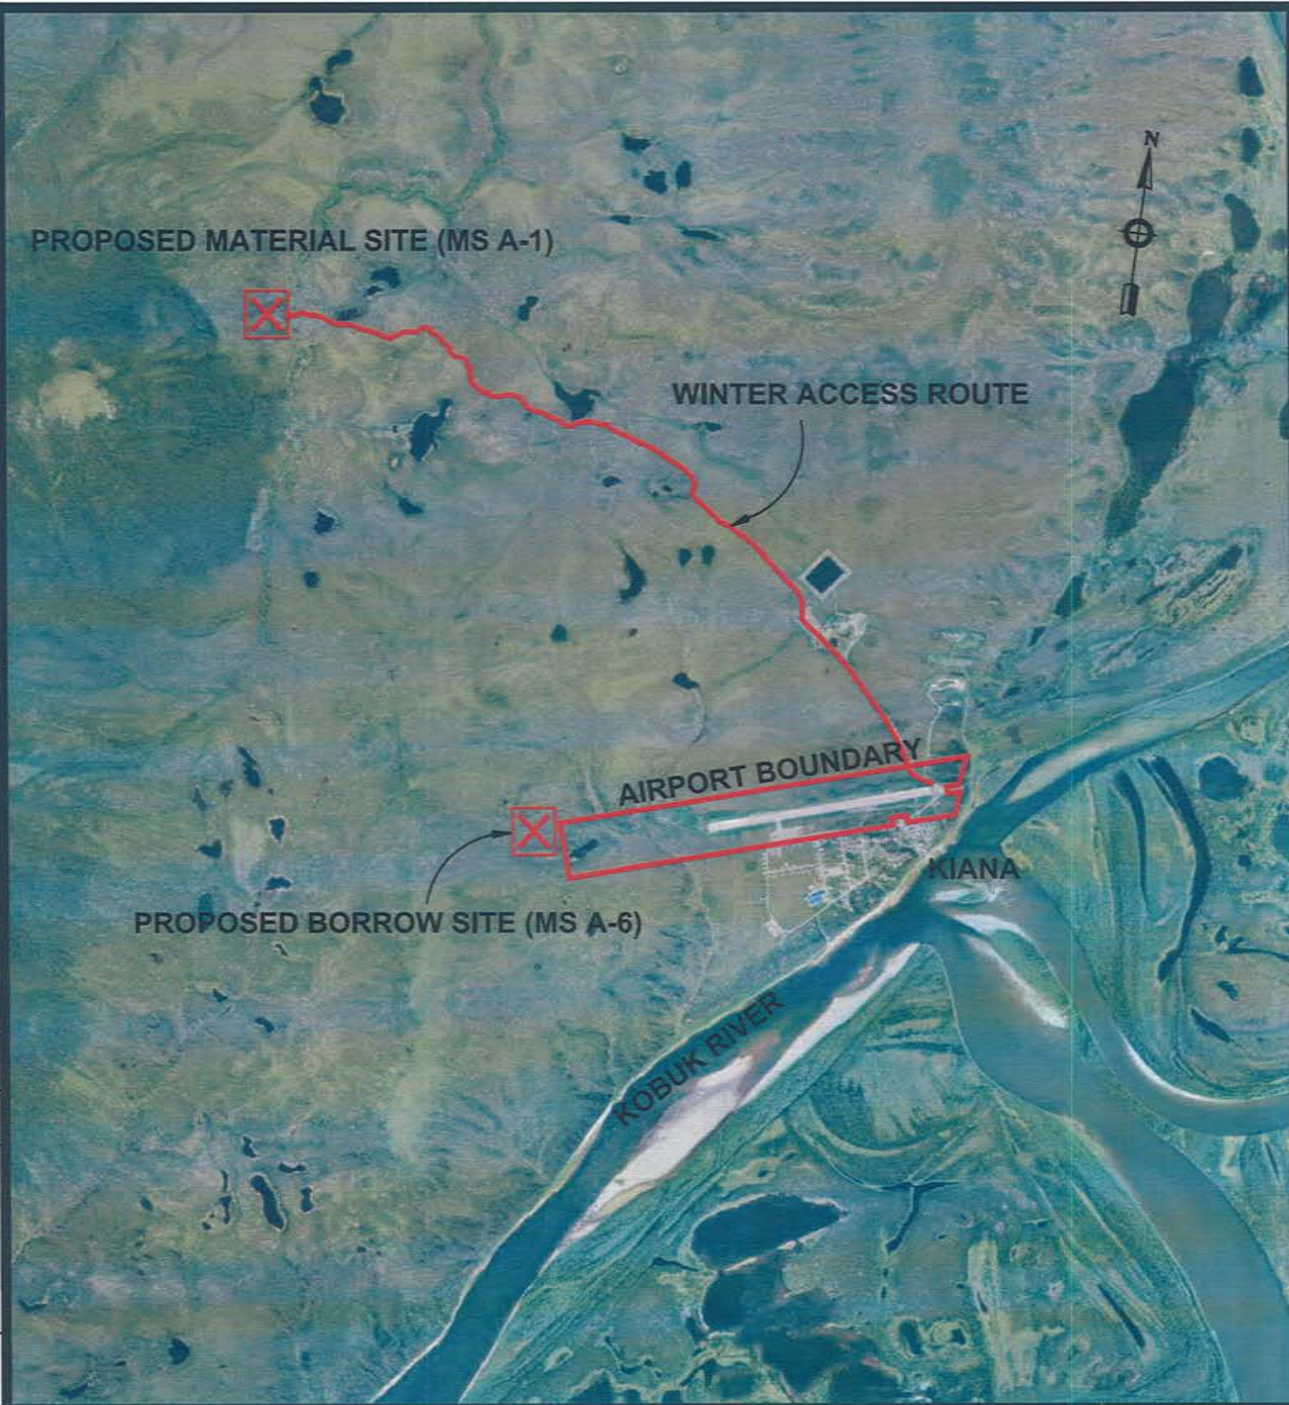
FIGURE 1

VICINITY MAP
 PROTRACTED T18N, R8W
 KATEEL RIVER MERIDIAN
 USGS SELAWIK (D3), ALASKA

The Alaska Department of Transportation and Public Facilities (ADOT&PF) Northern Region design engineers are evaluating alternatives for expansion or improvements to the Bob Baker Memorial Airport in Kiana, (Figure 1). Potential runway alternatives include:

To support the airport expansion or improvements project, NRMS personnel conducted a material source reconnaissance of 6 sites and drill investigation at proposed material source (MS A-1) northwest of the airport, and potential material source (MS A-6) to the west of the existing runway, (Figures 1 and 10).

Potential Material Site A-1 is undeveloped and located approximately 2.5 miles northwest of Kiana and the airport. The site is located within the Kateel River Meridian Baird Mountains topographic quadrangle sheet A-4, Section 31 of Township 19 North, Range 8 West, and at N67° 0.032' and W160° 30.106'. All-season access does not exist to the site, and for this investigation access was accomplished by snow machine along the route shown in Figure 1.

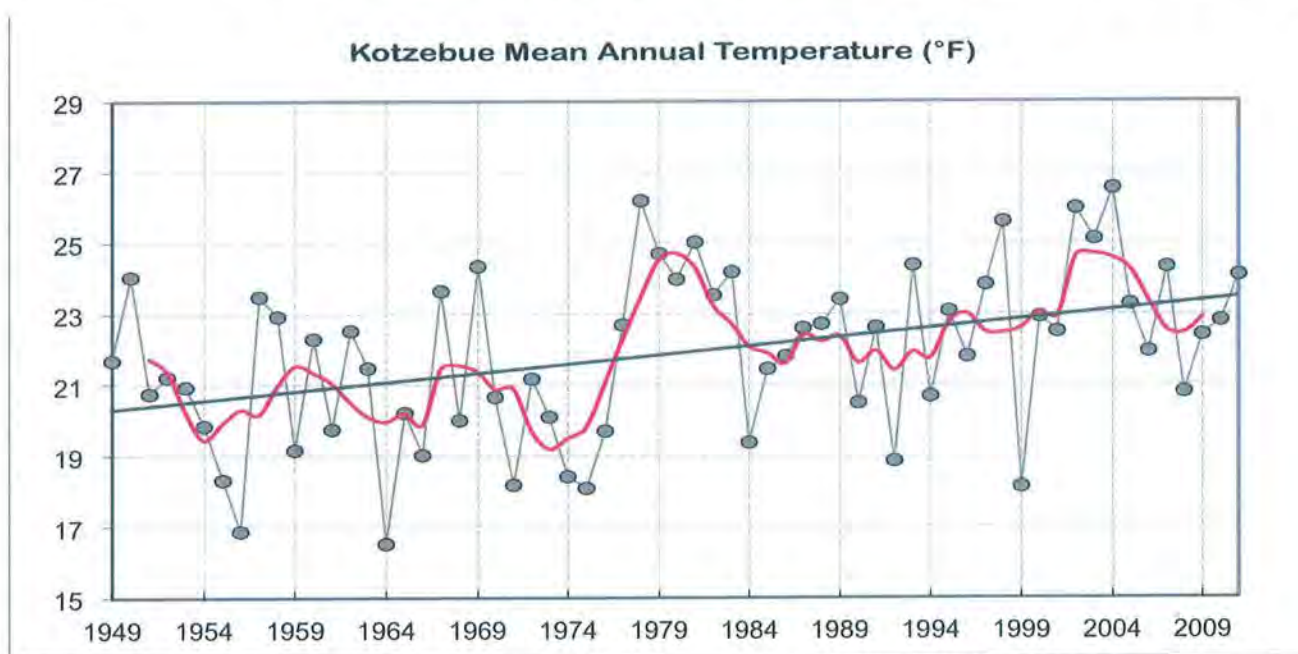
Figure 2 below is a graphic representation of mean annual temperatures from 1949 to 2009 for the Kotzebue Airport area. The red line is the 5 year average and the solid black line is the trend line.

Figure 2: Kotzebue Airport Mean Annual Temperature (°F) from 1949 to 2009. Data source: The Alaska Climate Research Center, Geophysical Institute at University Alaska Fairbanks, climate.gi.alaska.edu.

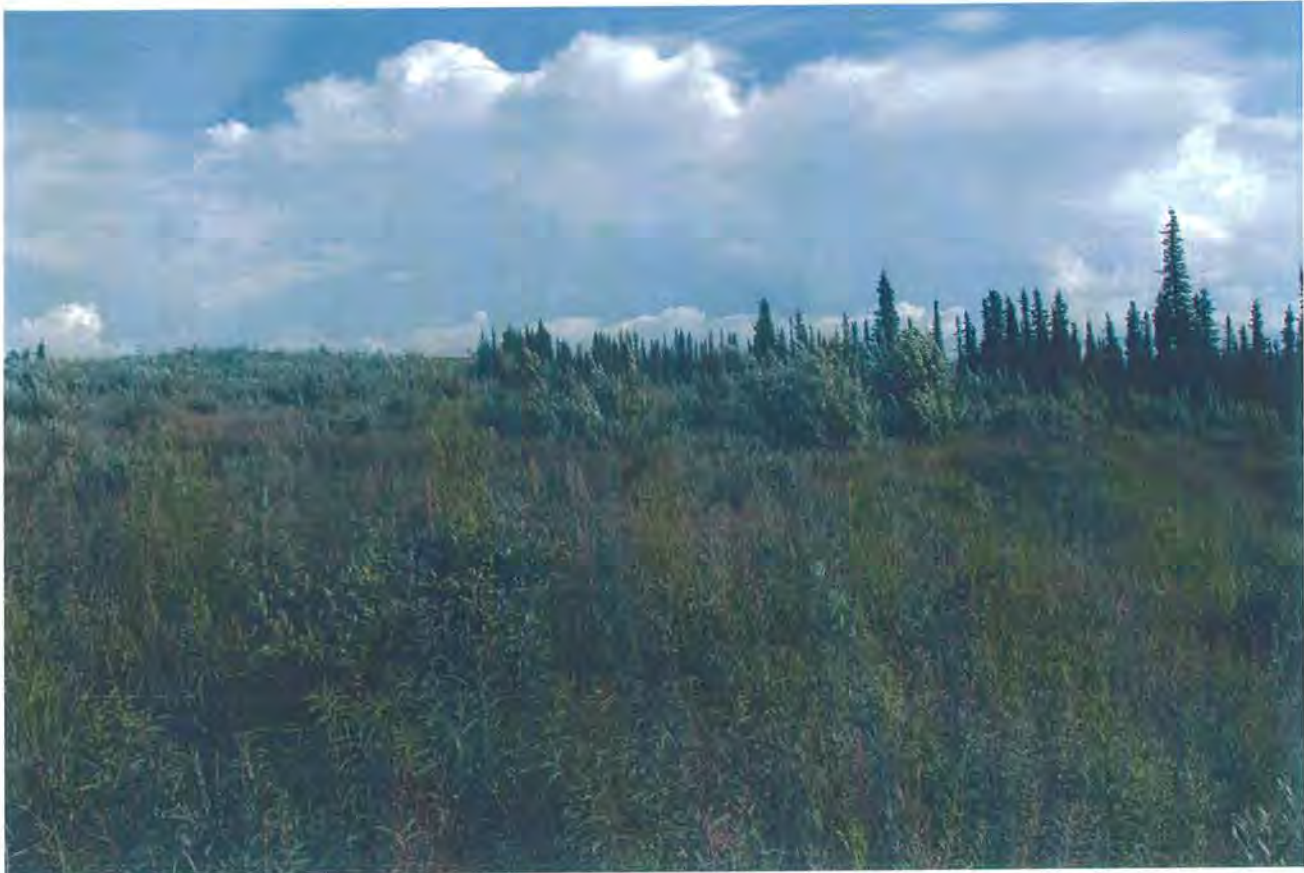
Figure 5: Disturbed area northwest of the existing runway, looking south toward proposed runway Option 1. The west end of the runway is to the left background.

An All Terrain Vehicle (ATV) trail exists at the fill slope toe of the western end of the existing runway. This area and 100 feet west, is disturbed ground covered with young thick brush as compared to the tundra area to the west. TH11-165 was located in this disturbed area and TH11-191 located just to the west in tundra. A large area to the northwest of the existing runway is also disturbed ground covered with young grasses and brush. The boundary between disturbed and undisturbed areas are marked by a line of spruce trees, as indicated below in Figure 5.

At the western end of Option 2, a second area has been disturbed, as shown in Figures 5 and 7. This area was explored as part of runway Options 2 and 3, and has young vegetation, settlement holes, and fissures at the surface in the area. Thawed material consisting of silt, silt with sand, sandy silt and

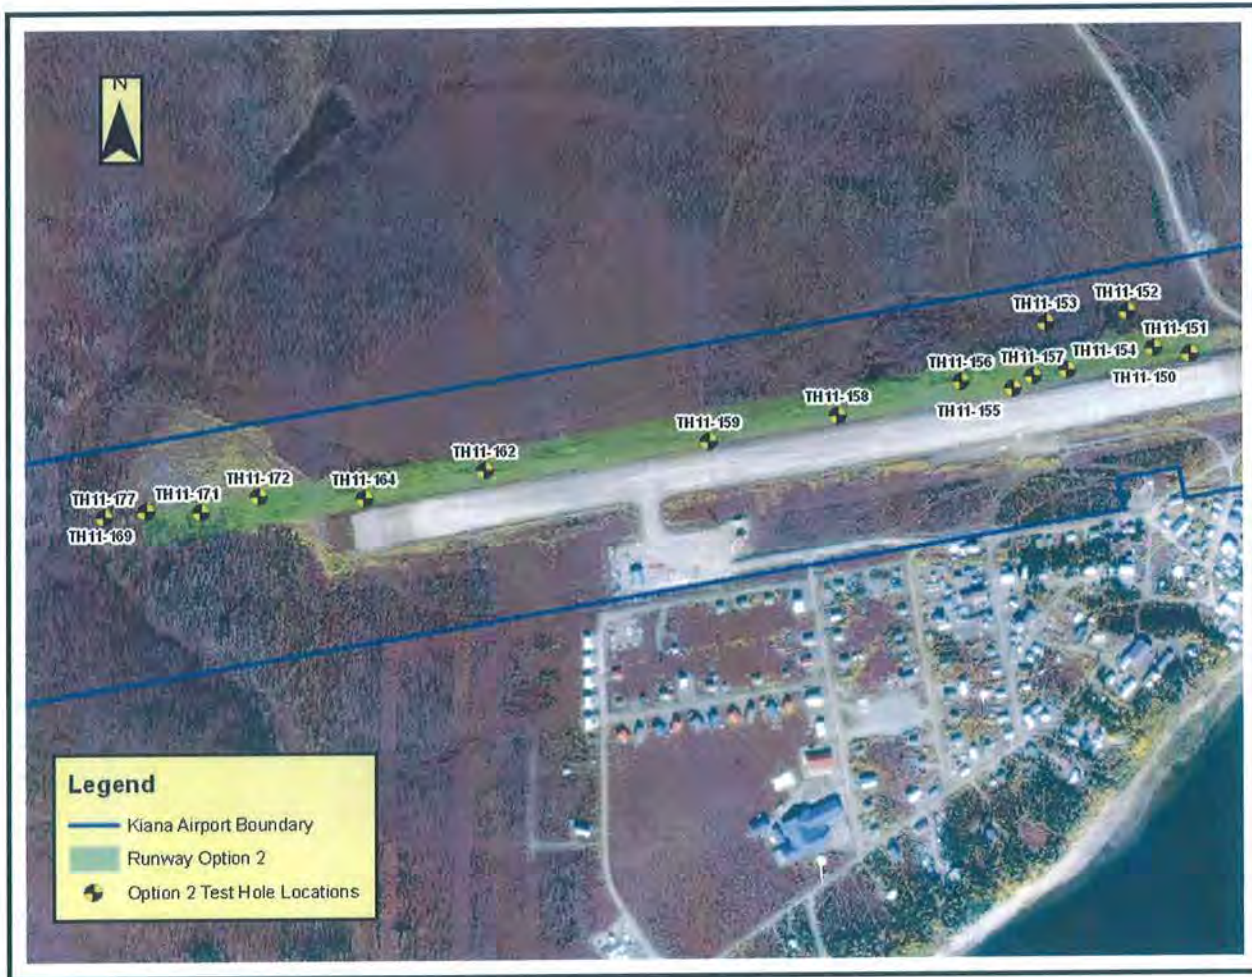
Figure 6: Proposed Runway Option 2, with Test Hole Locations.

Runway Option 2 involves relocating the entire runway north and adjacent to the existing runway, and extending to the west approximately 1,000 feet, (Figure 6). The area just north of the existing runway is thick with brush, grasses, and black spruce to 1 foot in diameter, except the west central portion, where vegetation is less abundant.

Fourteen test holes were drilled for runway Option 2, shown in Figure 6. These test holes were drilled north, northwest, and parallel to the existing runway from 90 to 250 feet north of the runway centerline. Two additional test holes, TH11-152 and 153 were drilled at a proposed aircraft parking apron approximately 300 feet north and northeast of the existing runway.

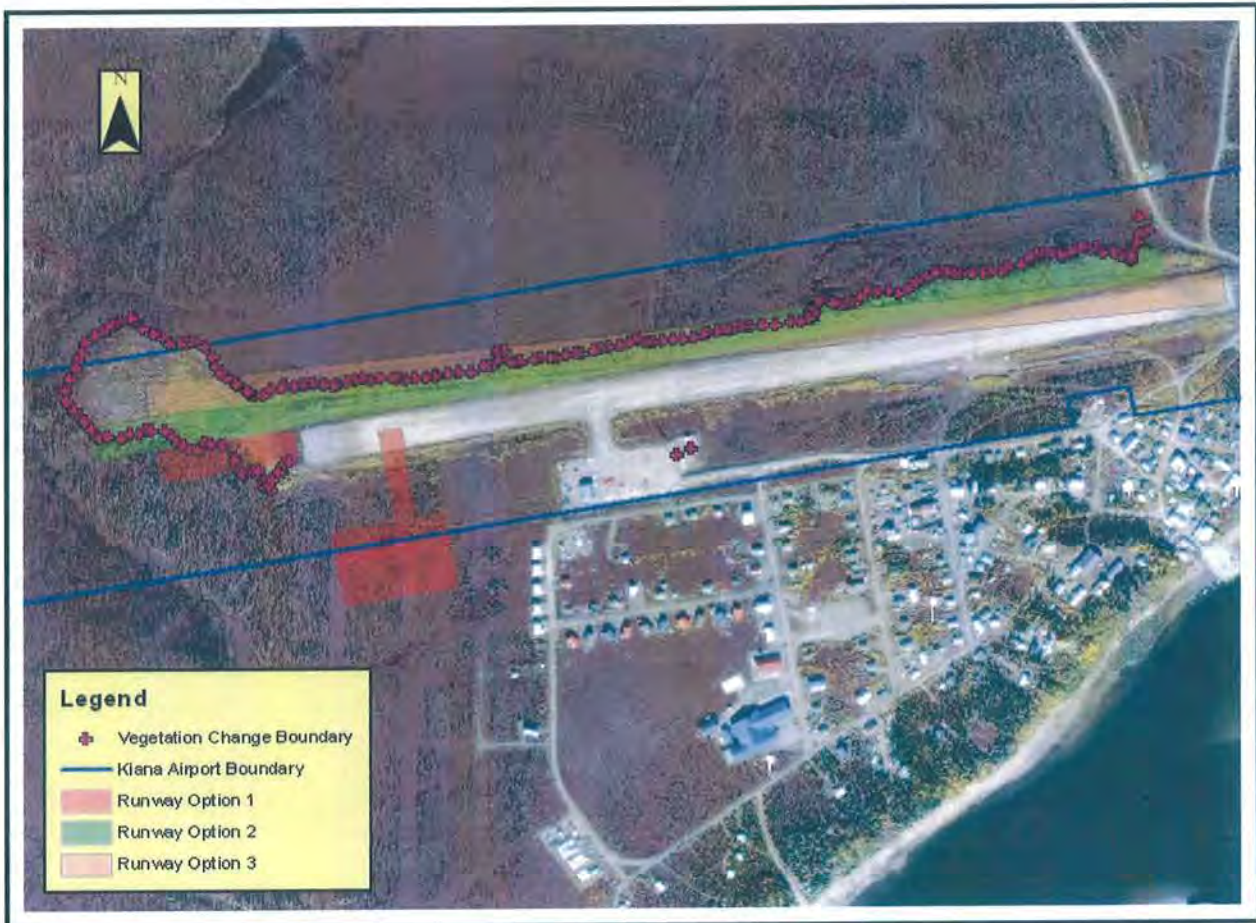
Figure 7: GPS Surveyed Abrupt Vegetation Change Boundary.

An abrupt vegetation difference is present along the northern edge of runway Option 2. Thick young vegetation is present near the existing runway and quickly changes to sparse tundra with stunted black spruce at approximately 250 feet north of the existing runway. The young vegetation area near the runway appears to have been disturbed, with uneven ground, sink holes, fissures, and debris or garbage observed. These features combined with test hole results indicate possible fill material spread throughout most of the Option 2 area. The origin of this fill material is unknown, but probably originated from previous runway construction work. The abrupt vegetation change was located with a hand held GPS, as shown in Figure 7, and one example location shown in Figure 8.

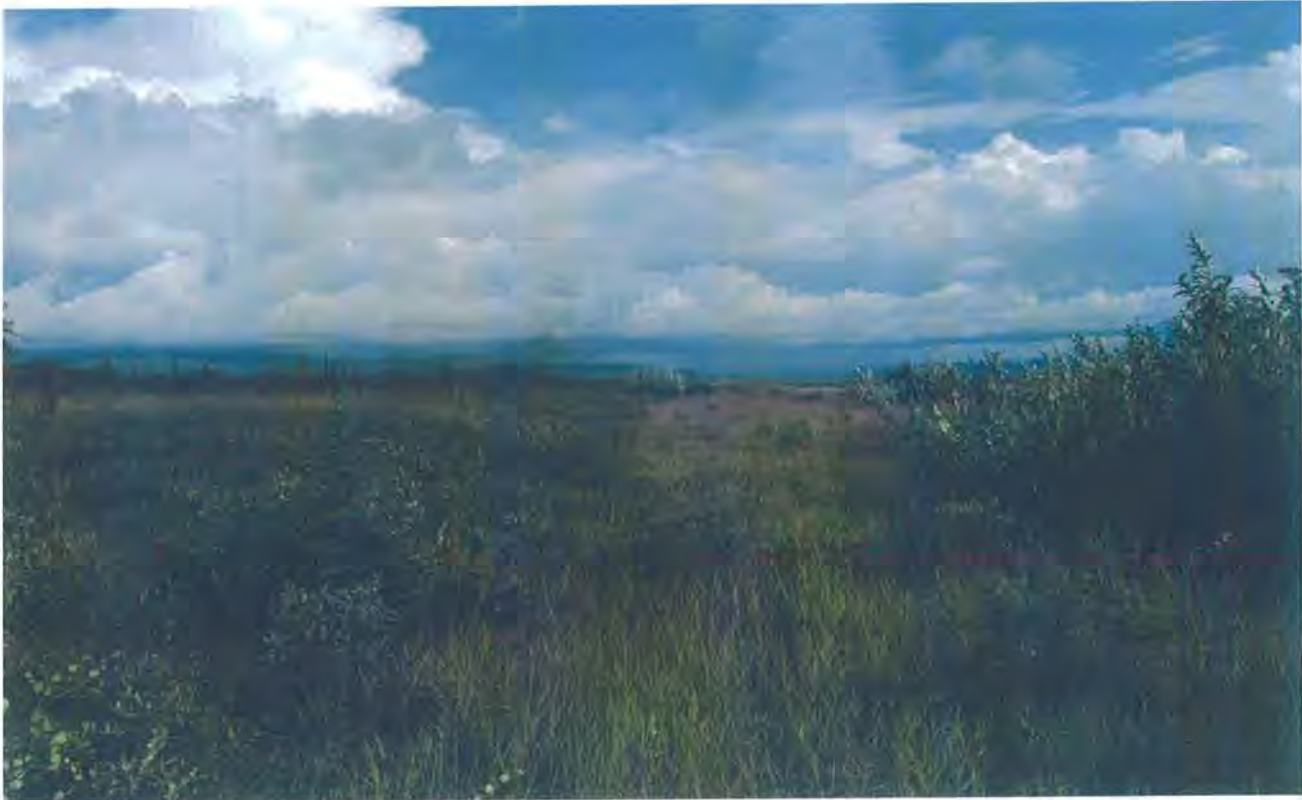
Figure 8: Abrupt Vegetation Change Contact. Boundary between young vegetation on the right and tundra vegetation on the left. Photo taken near TH11-160, looking east with the runway in the middle right background.

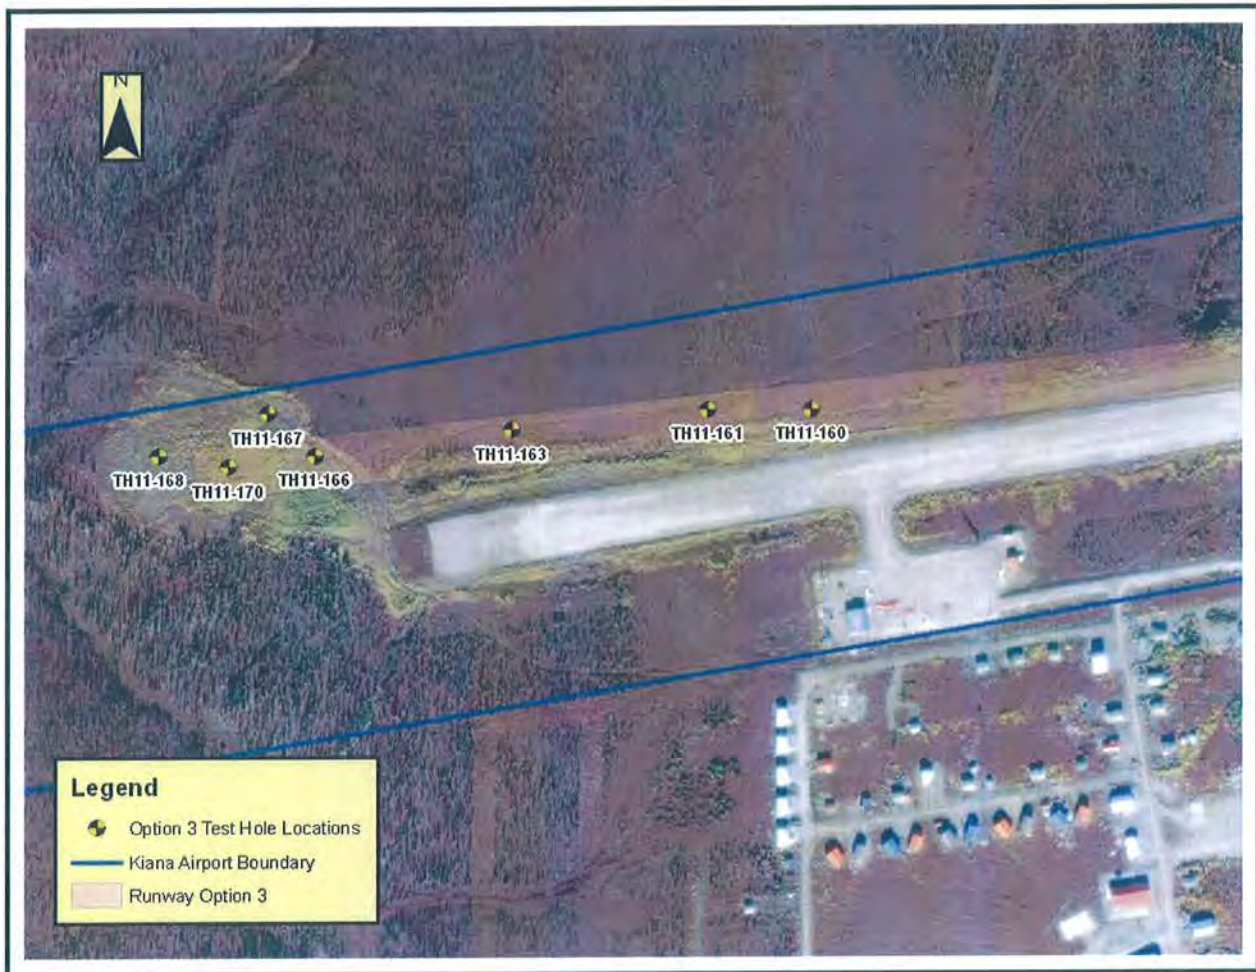
Figure 9: Proposed Runway Option 3, with Test Hole Locations

Test hole logs of all runway Option 3 test holes are included in Appendix A at the end of this report. Laboratory test results are included in Appendix B.
